# **A Method for the Investigation and Validation of Composite Pavement Performance Including the use of the Falling Weight Deflectometer**

Paper prepared for presentation at  
Pavement Evaluation 2002  
A Joint Conference of the FWD and Road Profilers User Groups  
October 2002  
Roanoke, Virginia

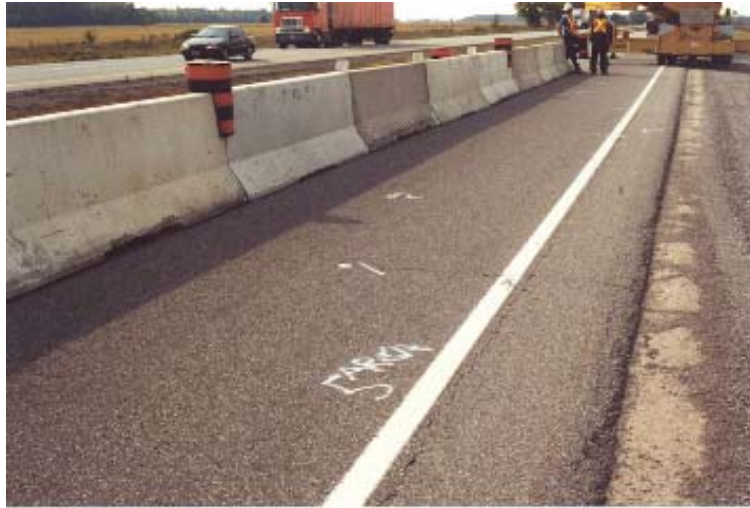
In general, the performance and ride of the easterly three pavement sections is good. The typical distresses are variable and comprise intermittent to extensive slight transverse and centreline cracking as well as moderate ravelling, very slight coarse aggregate loss and frequent

to intermittent slight distortions. Pavement edge cracks, midlane cracking and very slight wheel track rutting were also noted locally. A few blowups are also noted as well as concrete failures in the easternmost section. A photograph illustrating the typical pavement condition in the eastern PMS sections is provided in Figure 1.

Figure 1. Typical pavement condition in eastern PMS sections

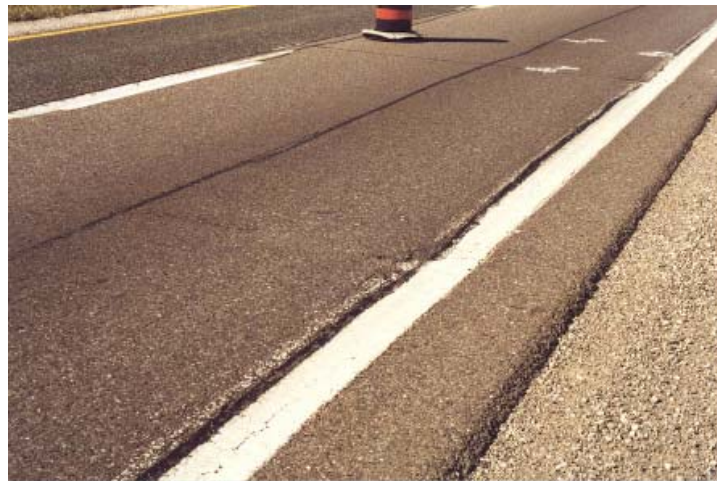
The performance and ride of the westernmost section is only fair. The primary distresses in this section are frequent severe transverse cracks, a few moderate centreline cracks, slight wheel track rutting throughout and a few areas of slight coarse aggregate loss and ravelling. An illustration of the typical pavement condition in the eastern PMS sections is provided in Figure 2.

Figure 2. Typical pavement condition in western PMS section

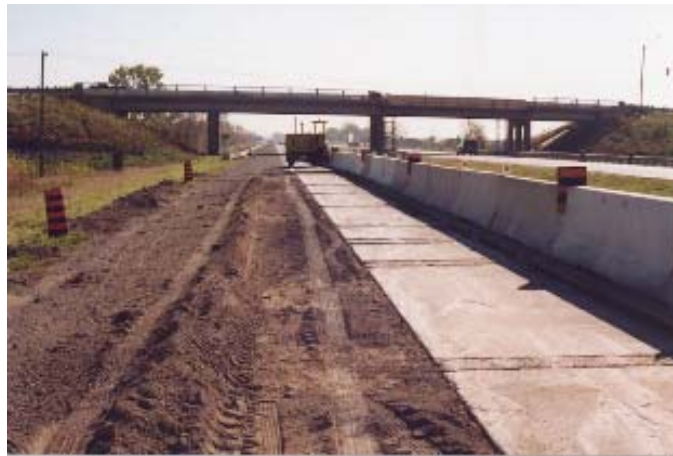
The majority of the concrete base surveyed was found to be in relatively good condition from the perspective of overall concrete quality. The predominant distress features consisted of joint/crack faulting, joint/crack spalling and mid-slab transverse cracking (Figure 3).

Figure 3. Typical concrete road base condition in western PMS sections (near Windsor). Note evidence of previous crack repair.

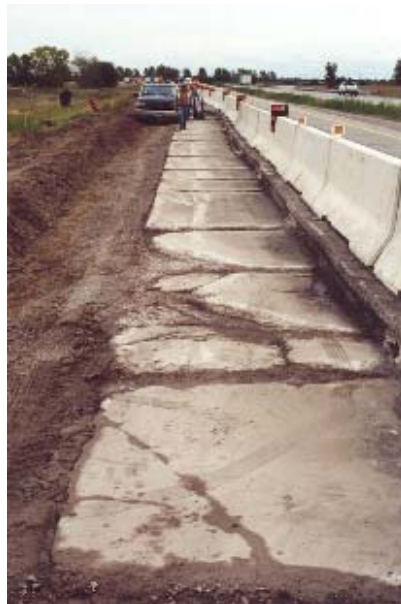
However, at the eastern end of the study area the joints and cracks were found to have deteriorated significantly resulting in a poor concrete road condition (Figure 4).

Along with faulting, spalling of joints and cracks was observed as a predominant defect in the concrete base. Spalling varied from slight to moderate in the better performing western PMS sections to severe to very severe at the eastern end of the study area.

Figure 4. Typical concrete road base condition in eastern PMS sections (near Tilbury).

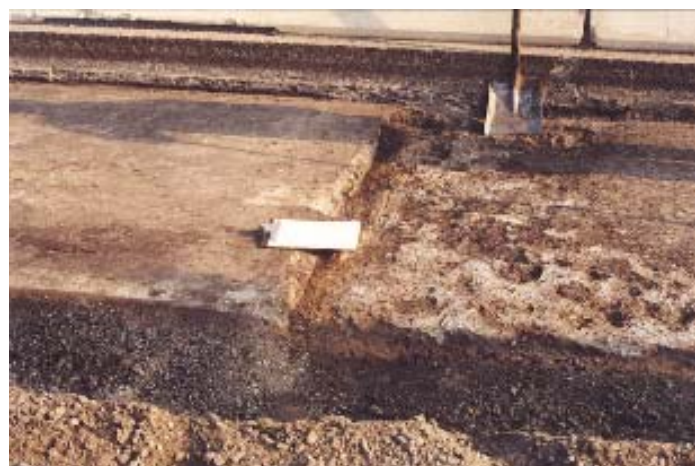
The occurrence of faulting at joints and cracks was noted throughout the study area. The severity of faulting varied from very slight to very severe (barely noticeable to in excess of 80 mm) but was predominately slight to moderate (5 to 10 mm). The most severe example of faulting was noted near the middle of the study area where the approach slab was some 80 mm higher than the leave slab. We refer to Figure 5 illustrating the very severe faulting. For an

exposed concrete pavement, the severity and frequency of faulting would result in poor ride quality. The very severe sections would be dangerous at posted highway speeds.

Figure 5. Severe concrete road base faulting.
