Pavement Asset Assessment For Secondary Roads

May 2002

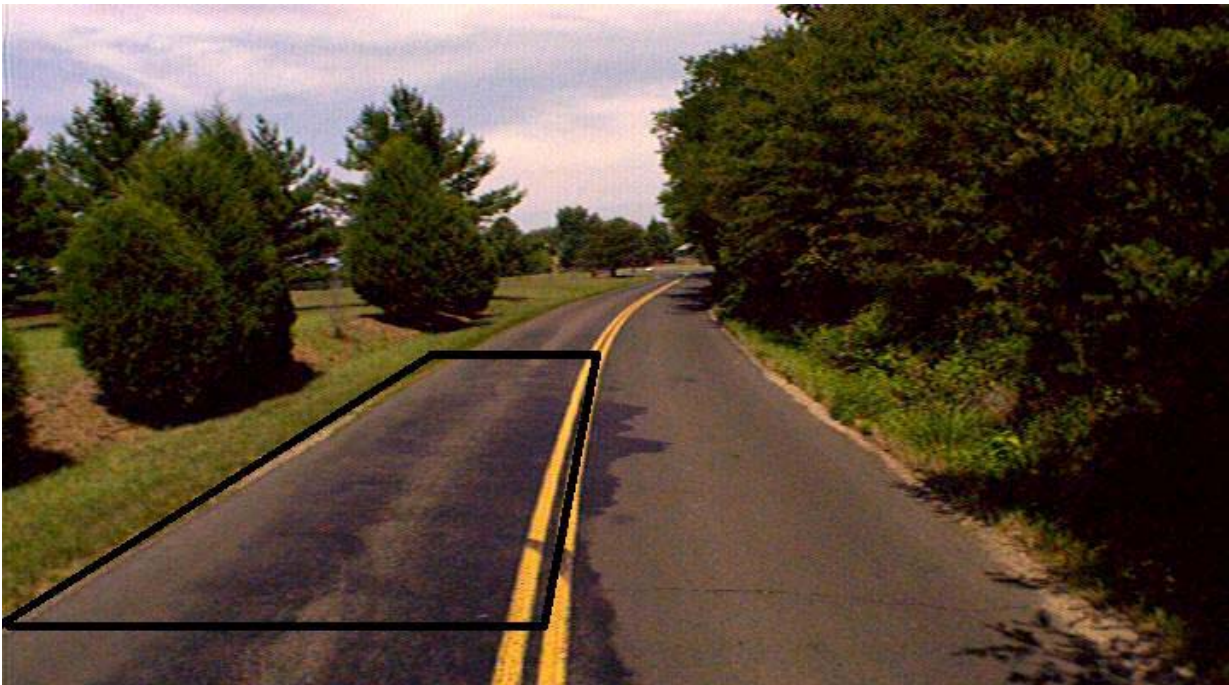
FIGURE 2 Sample of a forward image.

Either individual or multiple distresses can be recorded. To verify that lack of distress is not simply a rater error, the “No Distress” command was added. Also, the “Image Unrateable” command is used to indicate images which can not be viewed sufficiently clearly to determine a distress call. A sample image is provided as Figure 2.

The rater can select either the right or left forward camera images as the basis of rating. In addition, a rear left camera image is available, for further clarification of distress condition, however, the rating cannot be performed on the basis of the rear image alone.

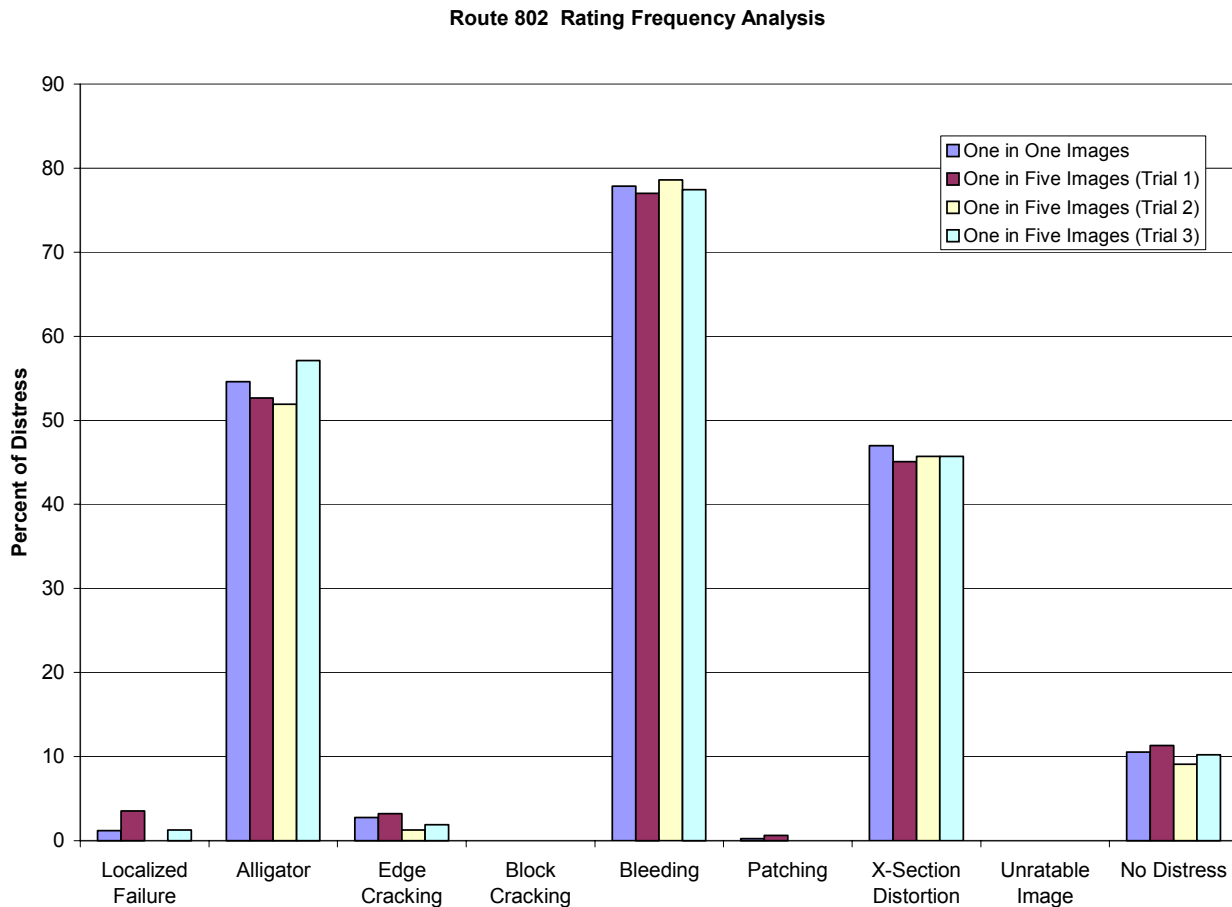
FIGURE 3 Distress summaries for different sampling frequencies.

A statistical assessment of sampling rates was conducted next. Representative data from the 200 miles was evaluated for this purpose. Sections were selected which contained variable levels of distress. Particularly, major VDOT distress types such as alligator cracking were assessed. A sampling rate of one image in five (20%) was determined to produce results only slightly different from the 100% sampling results. This was verified for several roadways, using different sets of sample images. These results are shown in Figure 3.
